6 September 2002

Work Order # 12634.001.001.0289.00  
TDD # S05-0207-012  
DCN: 289-2A-ACBX

Re: Acme Steel Company Site Assessment, Riverdale, Illinois

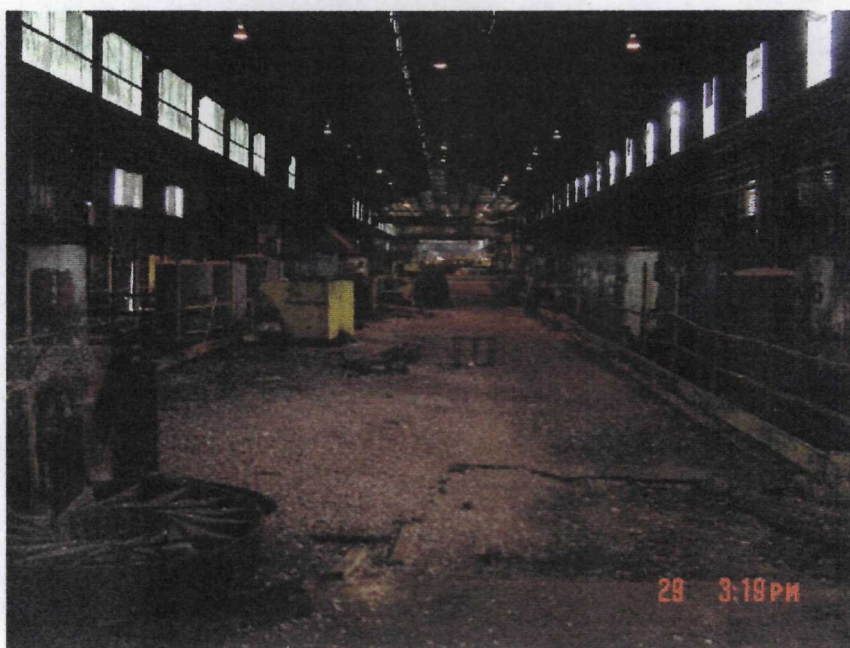
**SUBJECT:** Southeast end of Building 9, entryway.

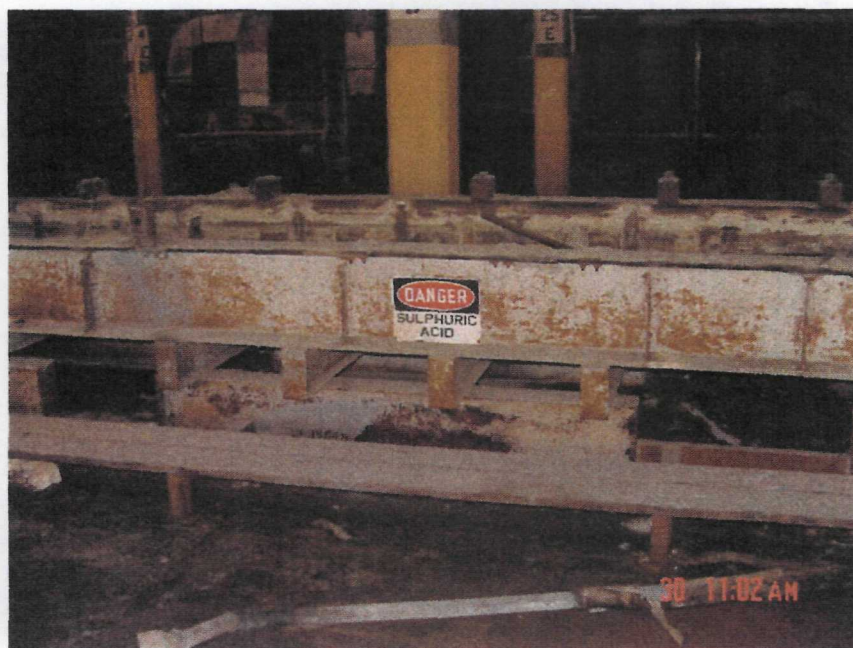
**SUBJECT:** Acid salts on floor near sulfuric acid tank at southeast end of Building 19, 2<sup>nd</sup> floor.

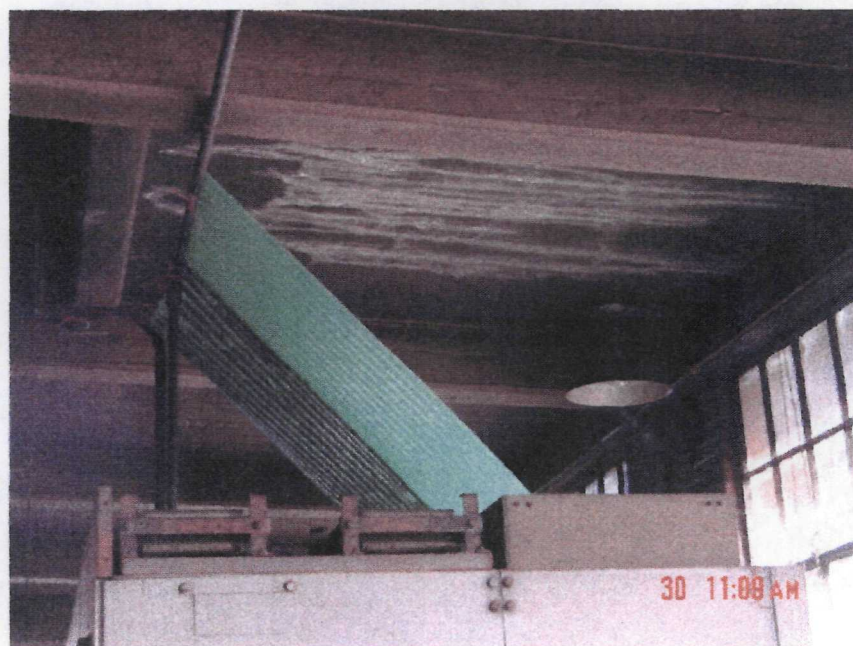
SUBJECT: Galvanizing trough in Building 19, 3<sup>rd</sup> floor.

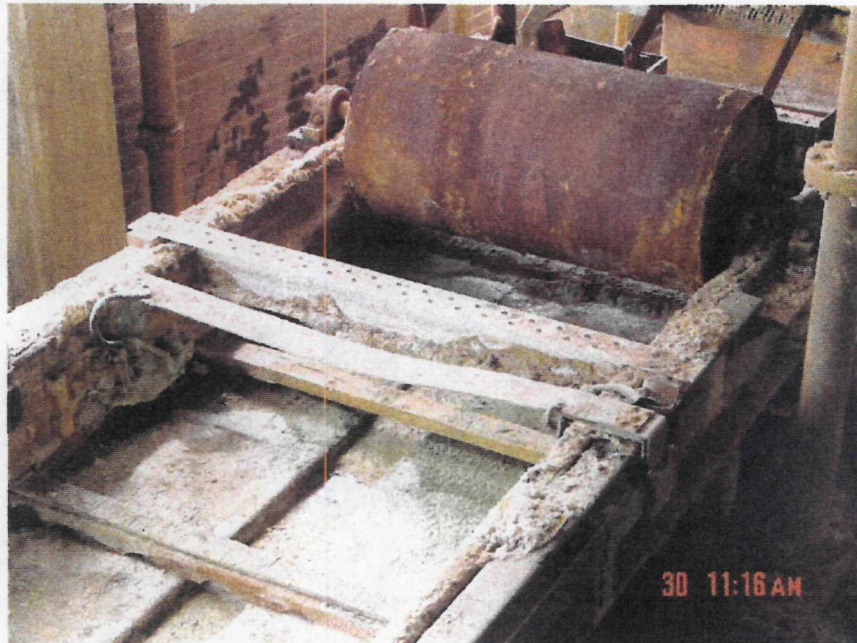
SUBJECT: Filling pipe with acid salts above electroplating vat in Building 19, 3<sup>rd</sup> floor.

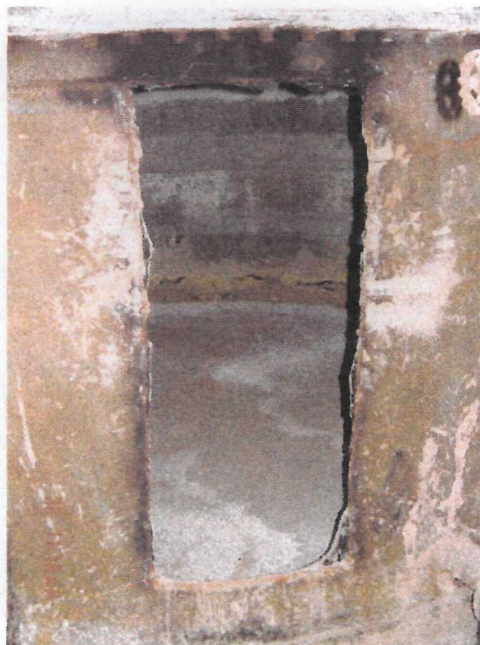
**SUBJECT:** Tank surrounded with zinc sulfate salts on floor in Building 19, 4<sup>th</sup> floor.

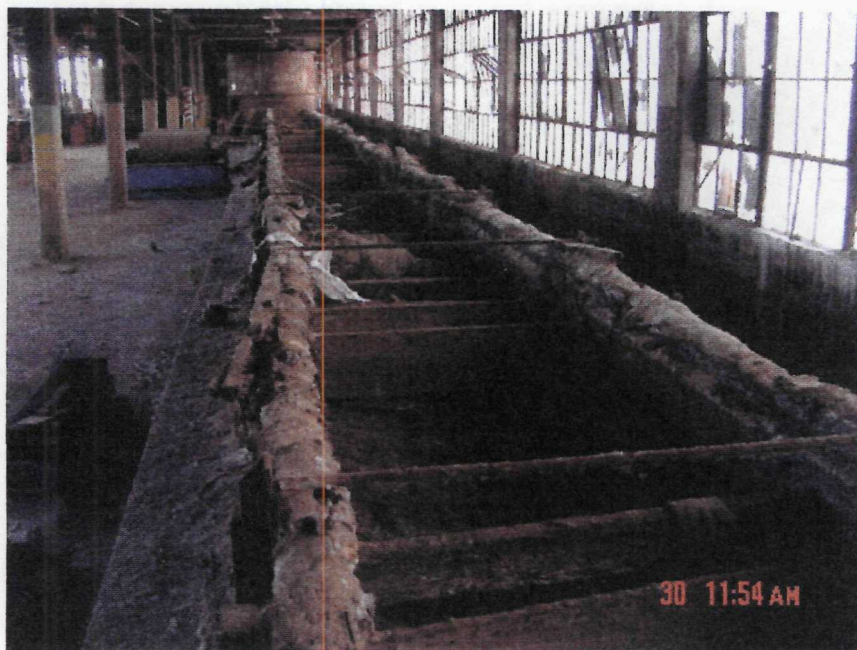
**SUBJECT:** Wooden plating vat, Building 17, 2<sup>nd</sup> floor.

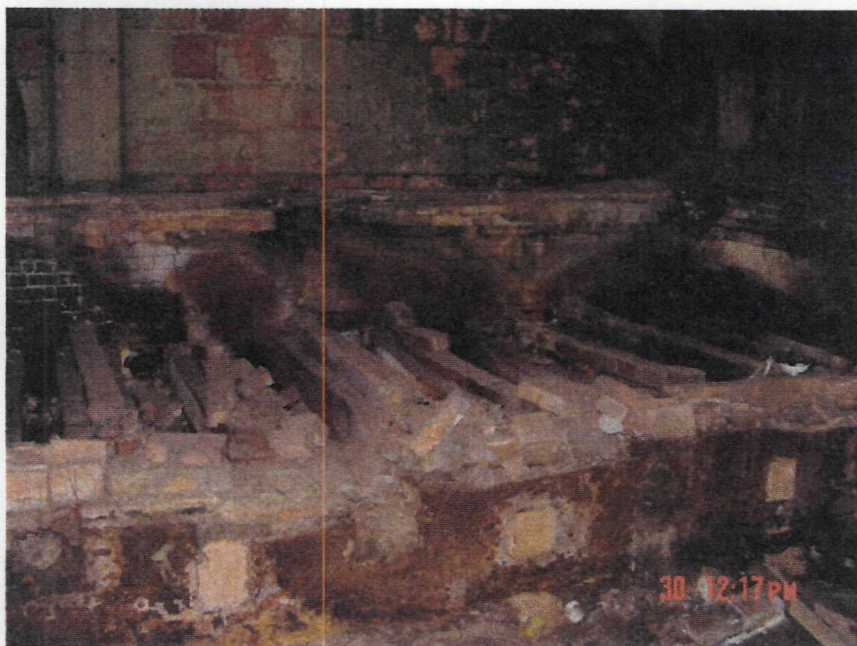
SUBJECT: Wooden plating vat, view of full line, Building 17,  
2<sup>nd</sup> floor.

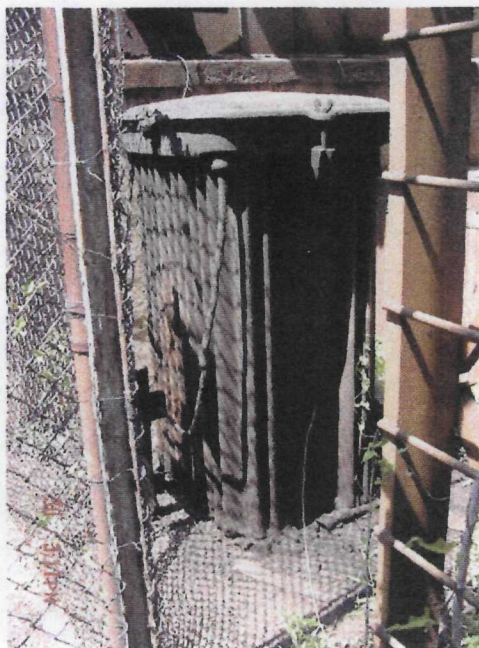
SUBJECT: Lead pot and smelting area, Building 17, 1<sup>st</sup> floor.

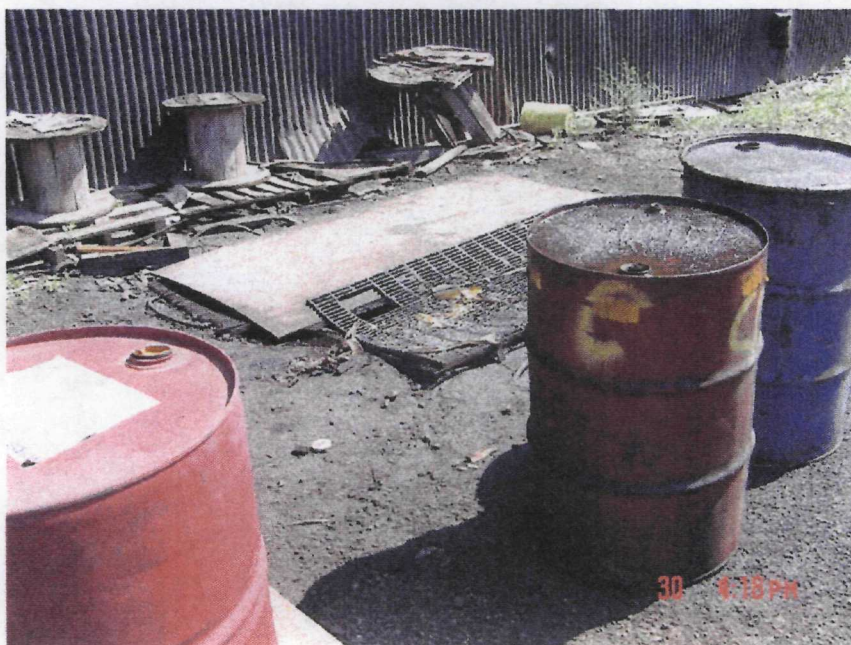
**SUBJECT:** 55-gallon drums in scarp pile north of Building 15, soil staining is apparent

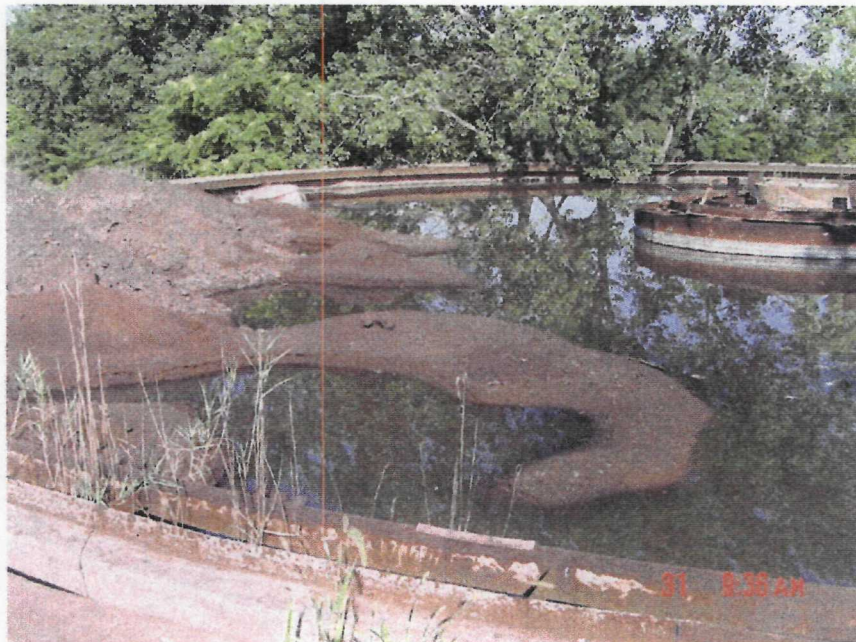
SUBJECT: **Coffer dam at river edge, oil is visible in left corner of the dam.**

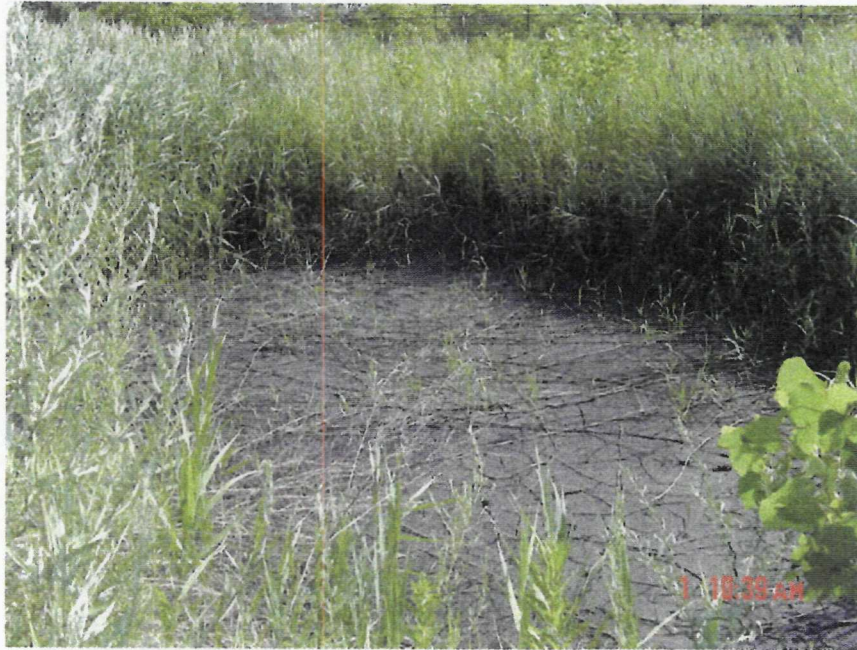
Yard	northwest of Maintenance Shop	Old transformer	OSC Collins requested testing of oil and soil for PCBs
Yard	north	Black, stained soil	Bermed impoundment; OSC Collins suggested this as a future sampling location
Yard	south of Locker Room Bldg	Six non-PCB transformers	
Yard	west of White Castle Bldg	Tank waste in roll-off boxes	OSC Collins suggested that material be shipped off-site for disposal
Yard	east of Junction House	Piles of sand from sand filter	Acme stated that sand will be tested and disposed of properly

SUBJECT: Old transformer near northwest corner of Maintenance Shop.

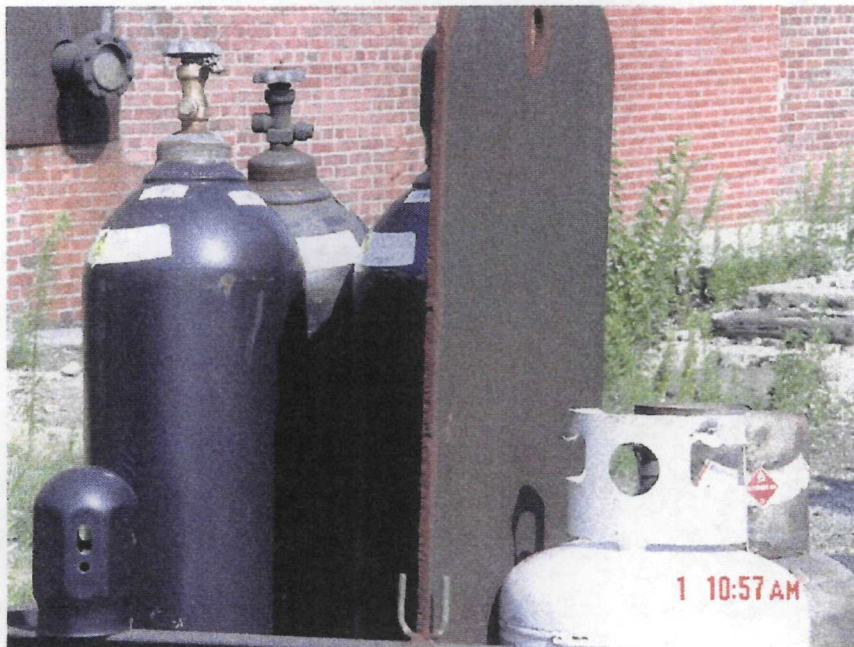
SUBJECT: Reportedly empty propane and oxygen tanks in storage together at east side of Powerhouse.
